TWR-18076

Field Joint Protection System Rain Qualification Final Test Report

11 May 1989

MORTON THIOKOL, INC.

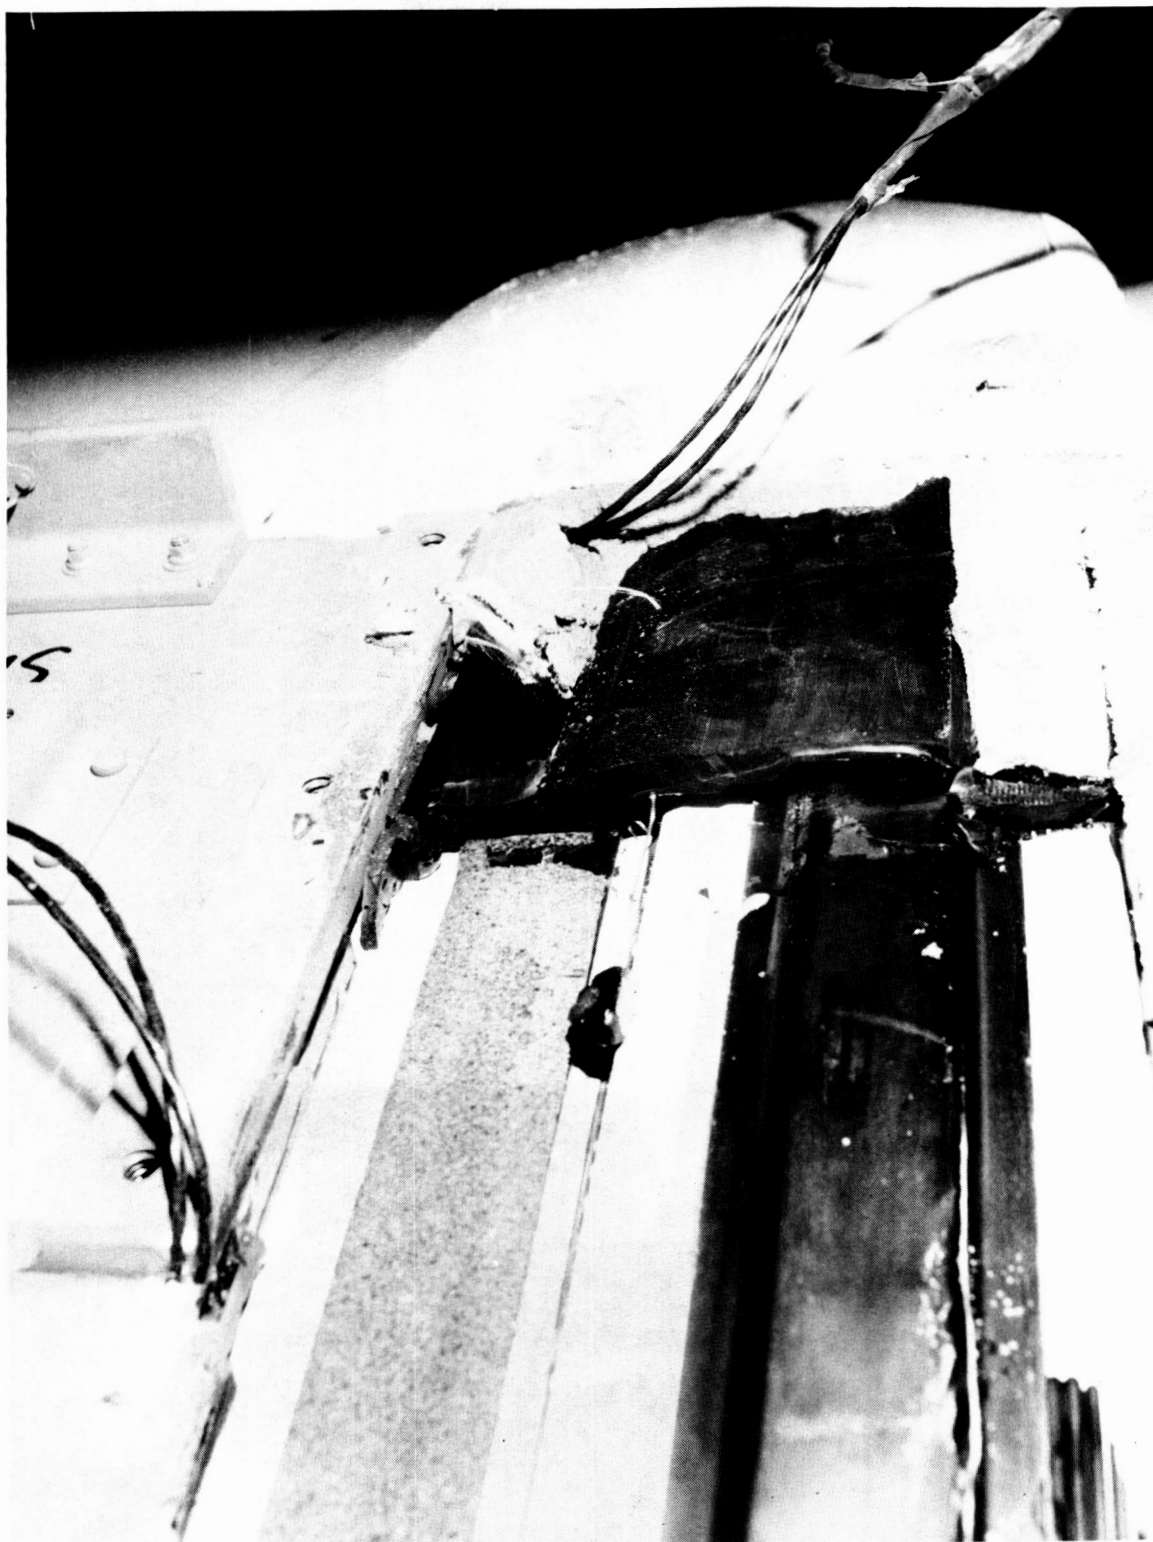
N109405-11

During the test, water entered through the open upper end of the systems tunnel and was funneled down between the tunnel and case. A sealant void at the moisture seal butt splice allowed this water to flow underneath the FJPS. The most likely cause of voids was improper bondline preparation, particularly on the moisture seal surface.

During disassembly, it became obvious that water had entered through the open upper end of the systems tunnel and was funneled down between the tunnel and case. A sealant void at the moisture seal butt splice allowed the water to flow into the FJPS (Figure 5). This void was located at approximately 90 deg, was 1 in. wide, and extended to the open space under the systems tunnel. The void was most likely due to improper bondline preparation and/or because the sealant may have been applied after its pot life had been exceeded. Sealant did not bond sufficiently to the moisture seal and the Kevlar retainer strap. A significant amount of water was found in this area. It was determined that this area was the major entrance for water into the FJPS. Once water entered this portion of the FJPS, it spread by capillary action around the case.

Figure 5. FJPS Rain Test—Moisture Seal Butt Splice, Sealant Unbond

Due to the omission of systems tunnel covers and systems tunnel floor plate closeout, the test assembly was not representative of flight hardware and resulted in a gross overtest. It is therefore recommended that the test be declared void. It is also recommended that the test be repeated. To improve the probability of moisture exclusion from the field joint, the retest should include a complete closeout of the systems tunnel, sealed systems tunnel ends, and improved adhesive bondline preparation.
